Property Inspections Unlimited Inc.

123 Example Crt
Anytown, ON K0A 2Z0

09/16/2018

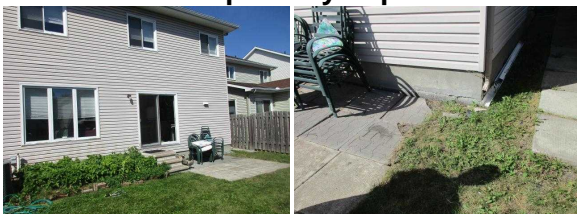
4. **Patio: Patio Stone - -Rear patio is sloping toward house foundation with low spots present. -Recommend repairs by a qualified contractor.**

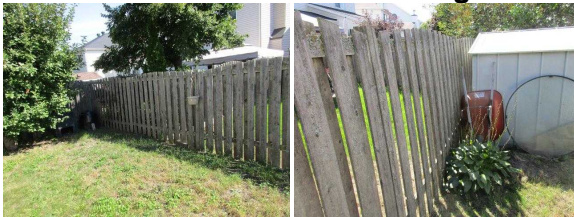
8. **Fences:** Wood - -Fence is leaning in several areas, repairs will be required in near future.

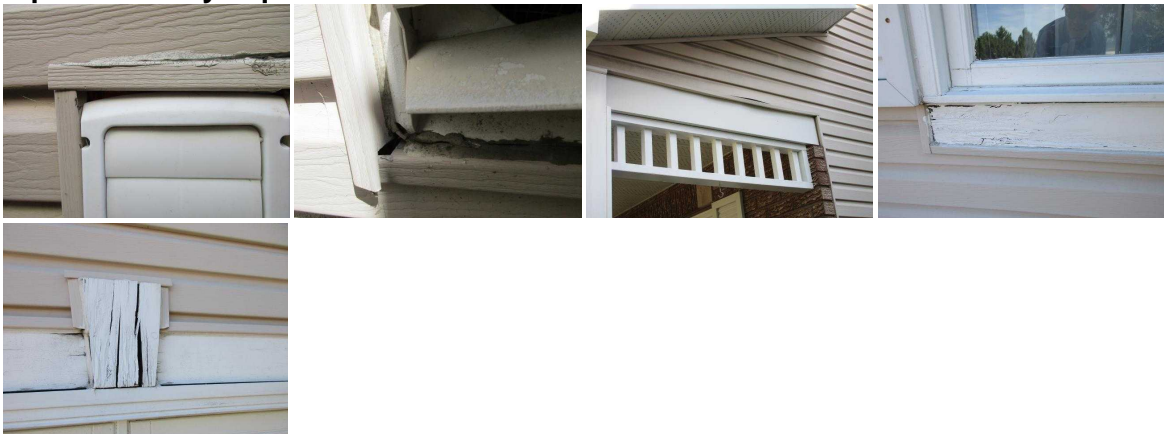
1. **Type:** Brick veneer, Vinyl siding - -Caulking seal needed around dryer vent piece on east side wall to prevent water and pest entry.
-Caulking seal required at bottom corners of one plastic vent on east side wall.
-Siding and J trim are not fitting properly on east side of front porch upper wall.

-Wood trim above and below upper level front windows has rot present. Recommend replacement by a qualified contractor.

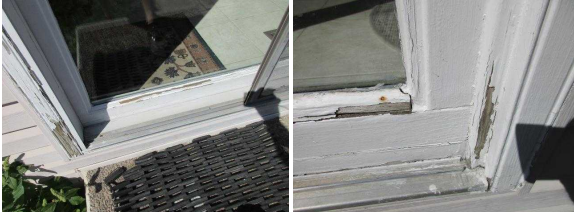
5. **Patio Door: Wood sliding** - -Paint and caulking seal needed around patio door.
-Screen does not slide well.
-Patio door will need replacement in near future due to age and condition.

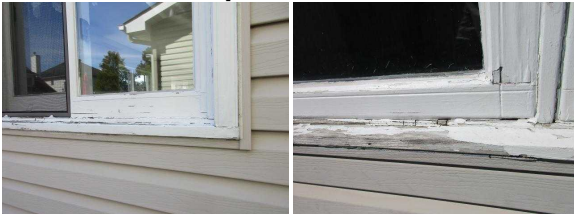
6. **Windows: Wood** - -All wood window portions require scrape, paint and caulking review to extend life.
-Recommend replacement of all wood windows in near future due to age and condition.

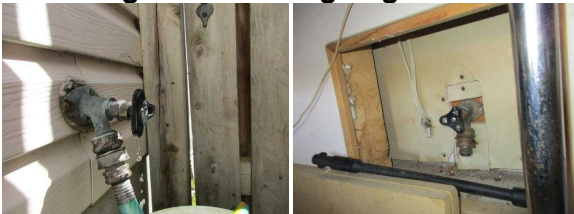
11. **Hose Bibs: Gate** - -West side faucet is leaking at hand when in use and must be cranked hard to fully shut off. Recommend repairs by a qualified plumbing contractor.

-Cannot get a hose on garage faucet due to wall framing.

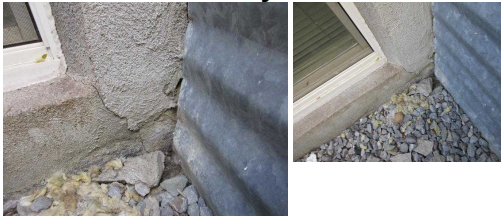
1. Foundation Type: **-Poured Concrete**
2. Foundation Condition: **Vertical Cracking** - - One vertical crack present in east foundation wall of home below basement window. Crack appears to be typical settlement, recommend parping coat repair above grade only at this time. Note: Further repairs may be required in future if water entry occurs at this crack location.

11. **Foundation Condition: Vertical Cracking - - One vertical crack present in east foundation wall of home below basement window. Crack appears to be typical settlement, recommend parging coat repair above grade only at this time. Note: Further repairs may be required in future if water entry occurs at this crack location.**

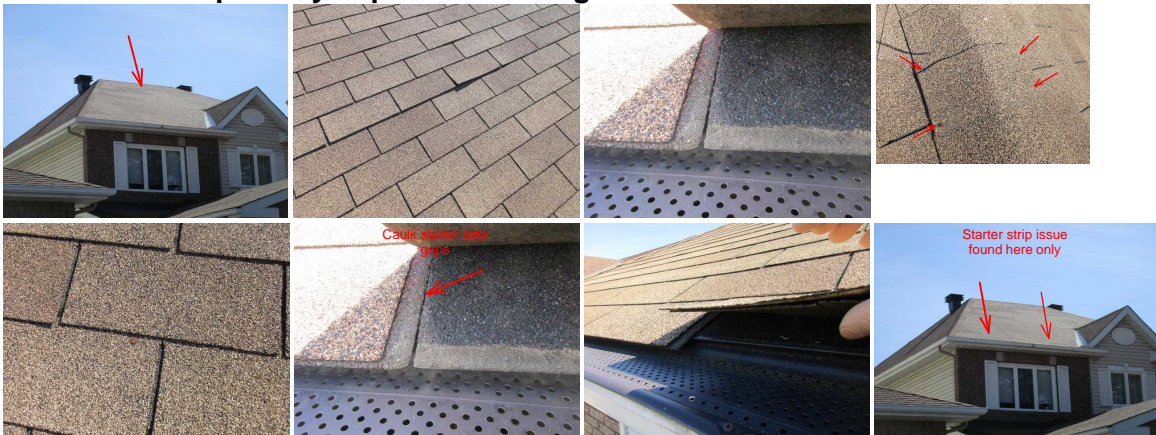
2. **Material: Asphalt shingle** - **-Several shingles across upper front section are not adhered well due due to tar paper under lower tabs.**
-Roofing nails on upper cap and one on front roof face require caulking seal to prevent water entry.

-Starter shingle is not aligned well at lower front east roof edge, the overlap of upper shingles lines up with gap in starter strip shingle. These are typically staggered better and could cause a leak. Recommend caulking seal of gaps between starter strip shingles. Recommend repairs by a qualified roofing contractor.

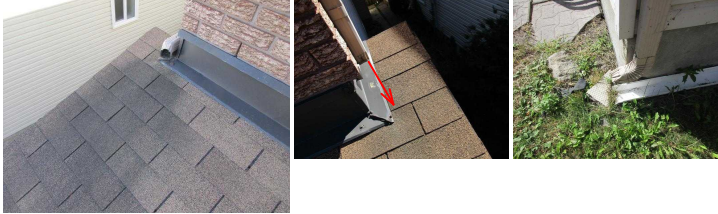
11. **Leader/Extension: Extensions Required** - **-Ensure downspout extension / leaders extend 4-6 feet away from house foundation.**

-Recommend downspout extensions be installed across lower front roof shingles from upper downspout to prevent wear on roof shingles. Recommend repairs by a qualified contractor.

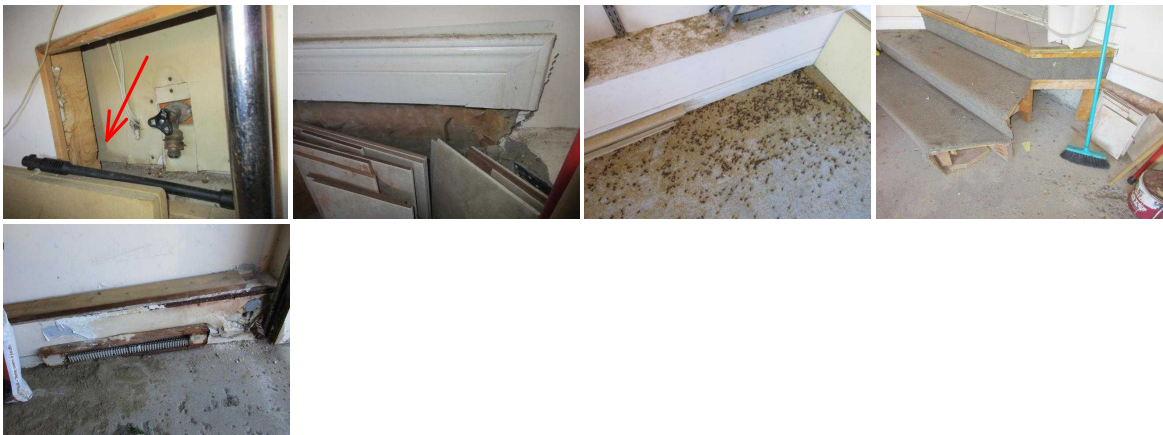
6. **Ceiling/Walls: -Reviewed - -Wall has been framed in front original rear wall of garage. Opening present for faucet must be sealed to prevent air entering home. -A rodent was seen entering this opening and large amounts of poop present on floor in garage. Recommend professional pest control. -Wall area needs repair and air seal at right of steps. -Drywall has moisture damage and mould in west side where garage foundation is covered over. Recommend repairs by a qualified contractor.**

-Stairs at house entrance door are unsafe. Recommend replacement by a qualified contractor.

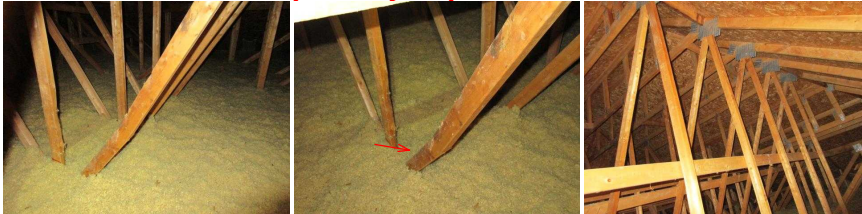
3. **Roof Framing: Truss** - **-One cracked wood truss member over master bedroom door in attic area. Recommend repairs by a qualified contractor.**

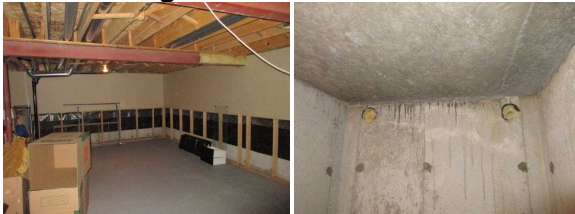
-Cold storage area vents are blocked with insulation and must remain open.

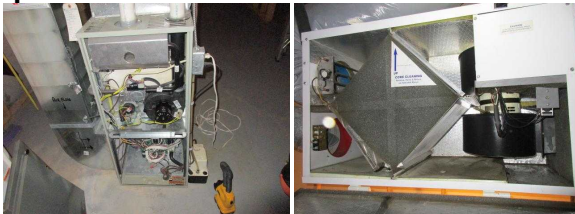
-HRV system does not appear to be working during inspection. Recommend repairs by a qualified HVAC contractor.

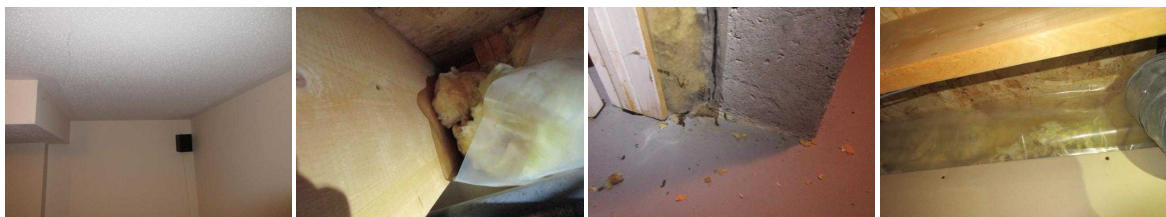
- 9. Vapor Barrier: **-Limited access**
- 10. Insulation: **-Limited access - -Appears rodent issues are present in east basement finished wall areas and possibly ceiling. Insulation levels along top of wall appear to be disturbed. -Poop and holes found in insulation and floor around cold storage area. -Poop and damaged insulation found in several header areas of basement unfinished walls. Recommend further evaluation and measures of entire home by a qualified pest control contractor.**

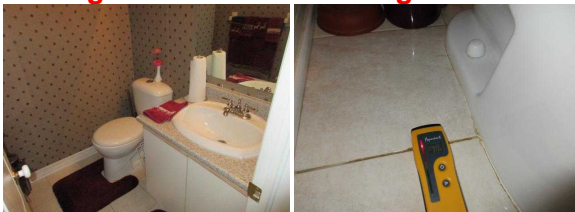
36. Toilets: **Repair Required - - High moisture readings taken around toilet on floor. Water leaking into basement ceiling. Recommend repairs by a qualified plumbing contractor.**

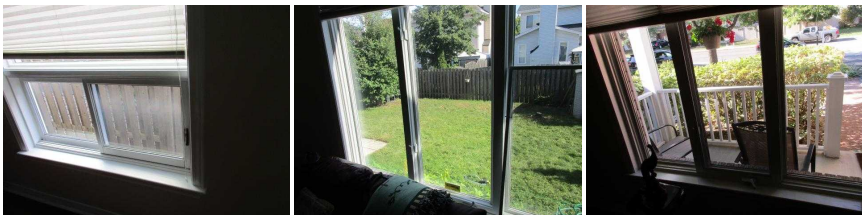
1. Closet: **Reviewed**
2. Ceiling: **Reviewed**
3. Walls: **Reviewed**
4. Floor: **Reviewed**
5. Doors: **Reviewed**
6. Windows: **Wood - -Will not open, recommend repairs or replacement by a qualified contractor.**

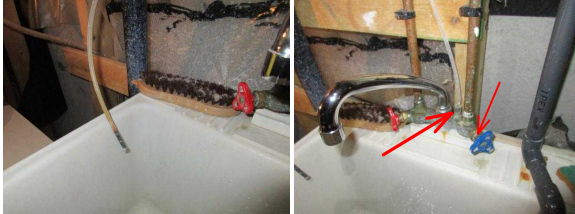
1. **Finishes: -Reviewed**
2. **HVAC Source: Heating system register**
3. **Laundry Tub: PVC - -Cold water tap trap seal primer portion is not connected to drain proper, recommend repairs to keep floor drain trap primed.
-Cold water tap is leaking water from valve packing near handle when water running. Recommend repairs by a qualified plumbing contractor.**
