Property Inspections Unlimited Inc.

123 Anywhere St
Bestown, ON K0A 2A0

Prepared for: Jon Doe

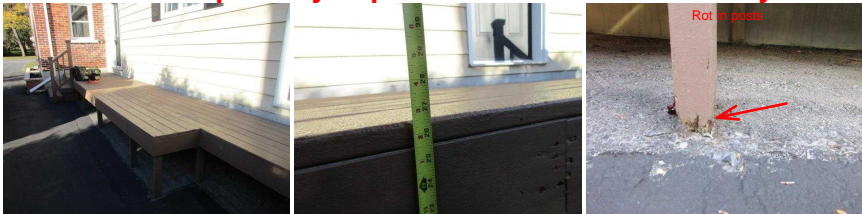
4. **Deck: Wood - -Support posts are not adequate and have rot at bottom.**

-Guard rail required around deck for safety.

Recommend repairs by a qualified contractor for safety.

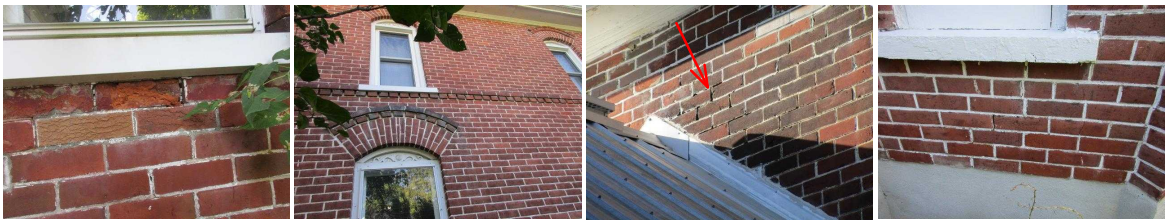
1. **Type: Vinyl siding, Brick - -Brick and masonry repairs required below rear living room window and at top of rear wall above lower roof peak.**
-General mortar joint and masonry repairs required around the home as part of regular maintenance.
Recommend repairs by a qualified masonry contractor.

-Cracked and damaged vinyl siding below main south entrance door.

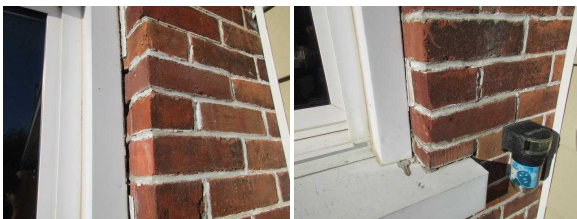
2. **Trim: Metal, Vinyl, Wood - -Caulking review and seal required around all window and door trim as gaps are present.**

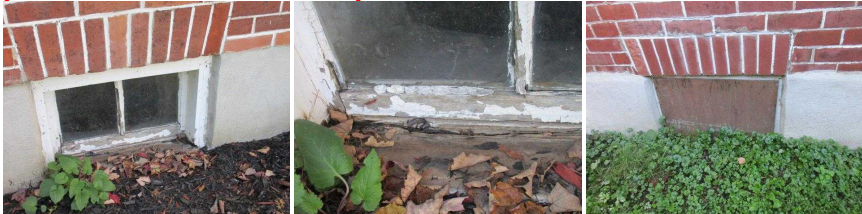
- 6. Basement Windows: **Wood** - - Older wood basement windows are quite weathered with rot present and should be replaced.

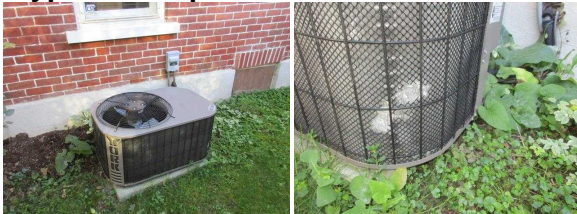
1. Manufacturer: **York**
2. Area Served: **Majority of building** Approximate Age: **10 years**
3. Fuel Type: **Electric**
4. Type: **Central A/C** Capacity: **2.5 Ton**
5. A/C System Operation: **Appears serviceable**
6. Condensate Removal: **Plastic tubing**
7. Exterior Unit: **Pad mounted - -Large dent present in right side of unit. Does not appear to be affecting operation.**

-Typical life span of exterior unit is 15-20 years.

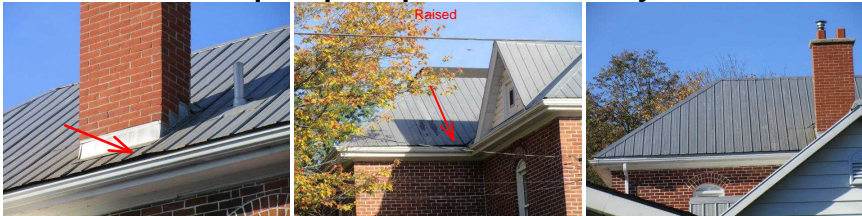
4. **Material: Metal** - -Portion of upper metal roof is raised at front south valley and at rear lower edge north of chimney. Recommend repairs by a qualified roofing contractor.

-Metal roof coverings require fastening and small hole seal review to prevent wind damage and water entry.

-Metal roof will require paint protection in 3-5 years time.

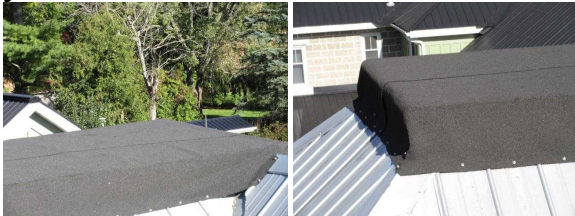
12. **Material: Rolled Asphalt Membrane - -Life expectancy of this material is likely approx 10 years from date of install.**

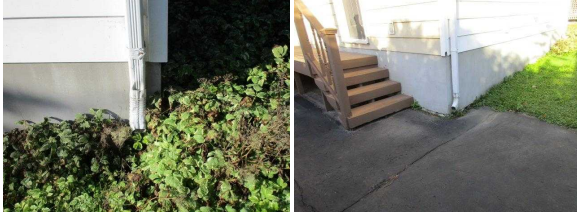
19. **Downspouts: Aluminum**
 20. **Leader/Extension: Extensions Required - - Ensure downspout extension / leaders extend 4-6 feet away from house foundation. All downspouts need extensions.**

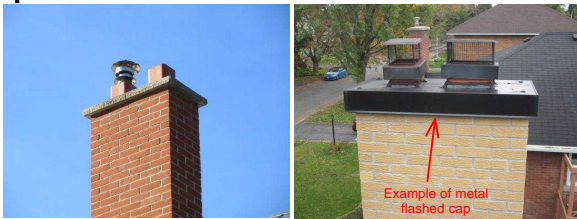
Rear Chimney

21. Chimney: **Masonry**
22. Flue/Flue Cap: **Concrete, Metal** - - Recommend metal flashing cap be installed over entire top portion of chimney to prevent future repairs to masonry. Recommend installation by a qualified contractor.

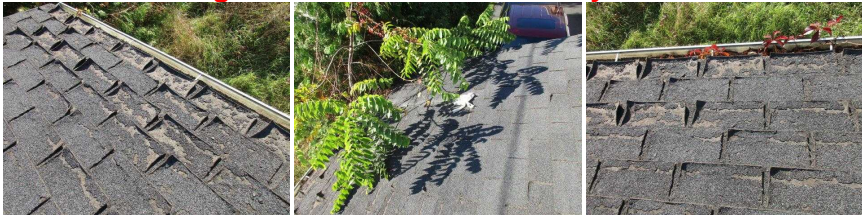
5. Roof: **Asphalt shingle - -Asphalt shingles require replacement, curling and general deterioration on south side. Recommend repairs by a qualified roofing contractor.**

-Trees and hedge need to be trimmed away.

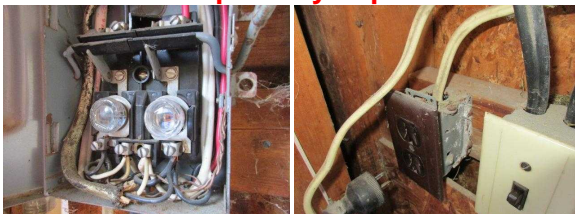
9. Electrical: **110 VAC/220 VAC - -Small fuse panel is over loaded with unsafe wiring present. Recommend repairs by a qualified electrical contractor for safety.**

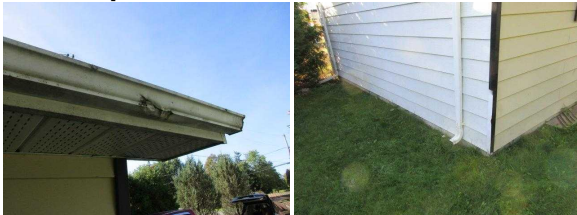
11. **Gutters/Downspouts: Aluminum** - -Front of north gutter is damaged and may leak water, monitor and repair as needed.

-Downspout extensions needed at rear.

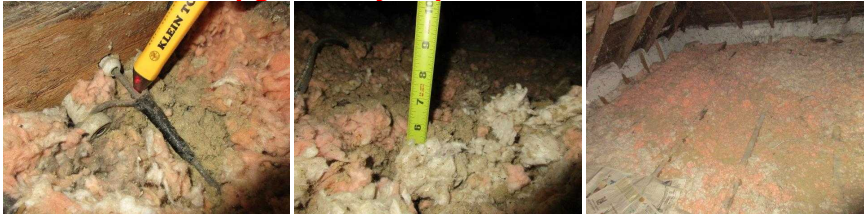
8. **Electrical:** - Unable to inspect all electrical components due to insulation cover. -**Knob and tube wiring present in attic that is still in use, power present. Recommend further evaluation and upgrades by a qualified electrical contractor for safety.**

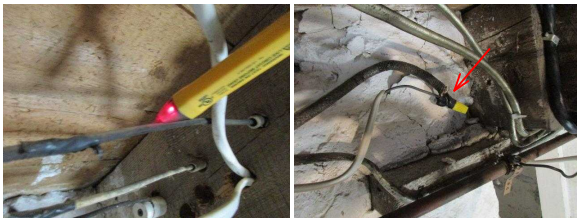
1. Service Entrance; **Reviewed**
2. 120 VAC Branch Circuits: **Copper - -Knob and tube wiring found in use in the homes upper attic space and basement south areas. Upgrades required by a qualified electrical contractor prior to purchase for safety.**

-Unsafe wiring connection in ceiling near entrance into south basement area. Fire hazard present.

Recommend repairs by a qualified electrical contractor.

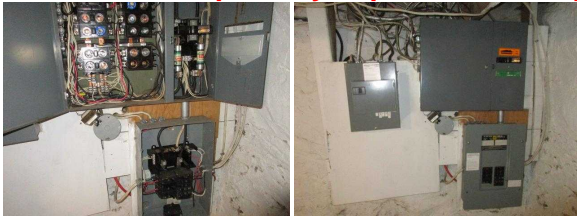
7. **Manufacturer: Amalgamated - -Older fuse panel still in use, recommend upgrade to newer breaker style for ease of use and safety.**
-Wood framing that panels and wiring are mounted on is not secure.
Recommend repairs by a qualified ESA approved electrical contractor.

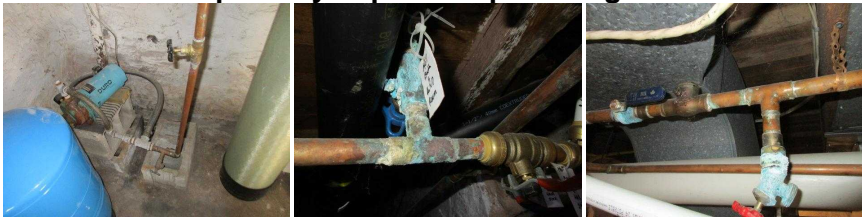
-Water pump is quite old and will likely need replacement in near future.

-Several corroded fittings present near furnace area in water supply piping.

Recommend repairs by a qualified plumbing contractor.

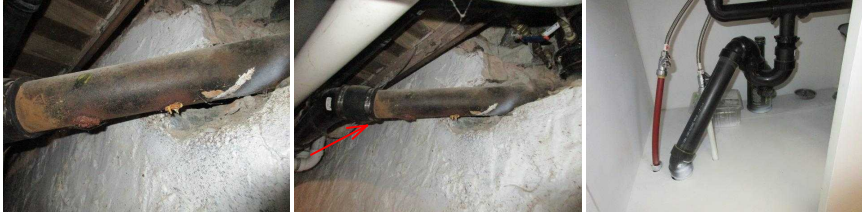
4. **Drain Pipes: ABS, Cast iron - -Cast iron drain piping is deteriorated behind furnace and leaking onto basement floor. poor slope in this pipe as well. Recommend repairs by a qualified plumbing contractor.**

-Drain piping below kitchen sink is not installed well, proper venting required.

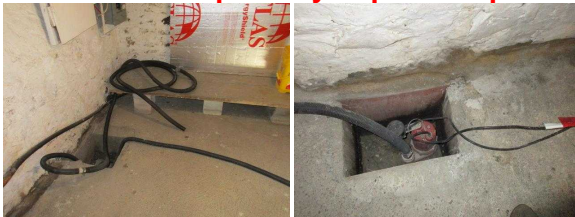
- 5. Service Caps: Accessible
- 6. Vent Pipes: ABS, Cast iron
- 7. Sump Pump: Submerged - **-Appears sump pump is used for water that runs across basement floor only.**

-Discharge piping is not permanently installed, appears basement window must be used to get hose to exterior.

Recommend repairs by a qualified plumbing contractor.

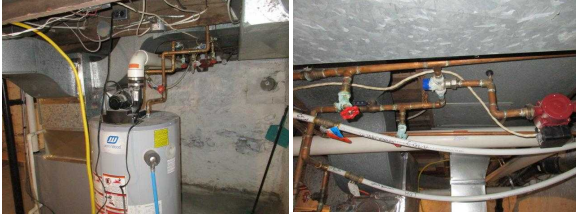
- 12. Water Heater Operation: Repair Required - **-Does not appear radiant floor hot water is being properly separated from domestic hot water. Recommend a heat exchanger be installed by a qualified plumbing contractor.**

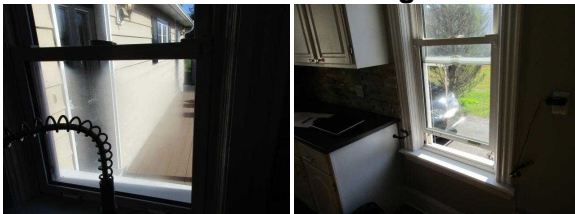
- 3. Disposal:
- 4. Refrigerator: **Reviewed**
- 5. Sink: **-Reviewed**
- 6. Electrical: **110 VAC, 110 VAC GFCI**
- 7. Plumbing/Fixtures: **-Reviewed**
- 8. Counter Tops: **Reviewed**
- 9. Cabinets: **Reviewed**
- 10. Ceiling: **Reviewed**
- 11. Walls: **Reviewed**
- 12. Floor: **Reviewed**
- 13. Windows: **-Vinyl - -Two fogged thermal panes present in separate windows. Thermal value is reduced.**

-Window screens are missing.

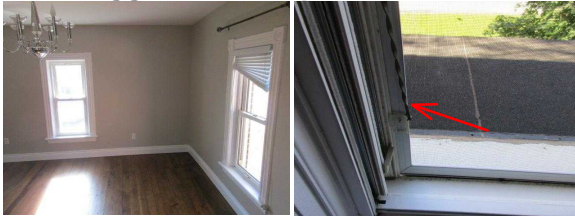
1. Closet: **Reviewed**
2. Ceiling: **Reviewed**
3. Walls: **Reviewed**
4. Floor: **Reviewed**
5. Doors: **Reviewed**
6. Windows: **-Vinyl - -Hardware for holding windows up is damaged in several windows.**

-Screens missing in master bedroom windows.

-Two fogged thermal panes in master bedroom windows.
